## DTC P0335 CKP SENSOR (POS)

#### Component Description

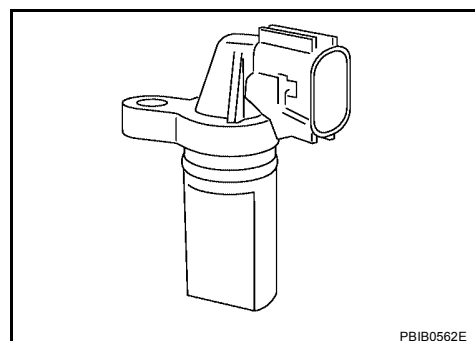
PBIB0562E

The crankshaft position sensor (POS) is located on the oil pan facing the gear teeth (cogs) of the signal plate. It detects the fluctuation of the engine revolution.

The sensor consists of a permanent magnet and Hall IC.

When the engine is running, the high and low parts of the teeth cause the gap with the sensor to change.

The changing gap causes the magnetic field near the sensor to change.

Due to the changing magnetic field, the voltage from the sensor changes.

The ECM receives the voltage signal and detects the fluctuation of the engine revolution.

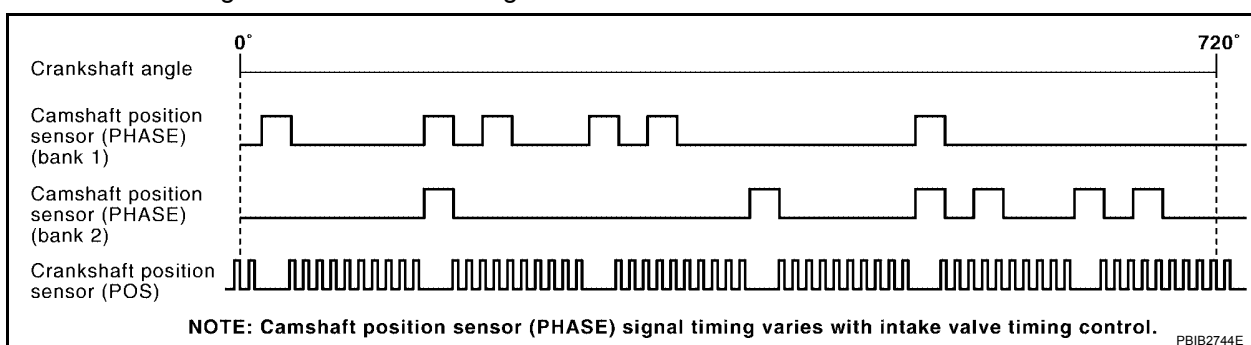
ECM receives the signals as shown in the figure.
