DTC P0335 CKP SENSOR (POS)

Component Description

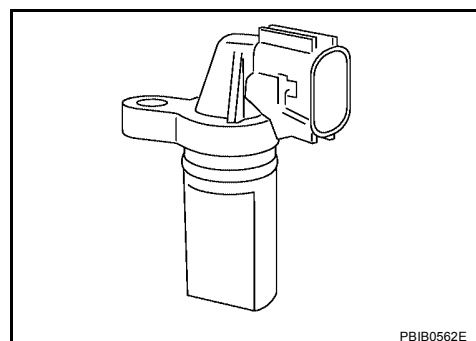
PBIB0562E

The crankshaft position sensor (POS) is located on the oil pan facing the gear teeth (cogs) of the signal plate. It detects the fluctuation of the engine revolution.

The sensor consists of a permanent magnet and Hall IC.

When the engine is running, the high and low parts of the teeth cause the gap with the sensor to change.

The changing gap causes the magnetic field near the sensor to change.

Due to the changing magnetic field, the voltage from the sensor changes.

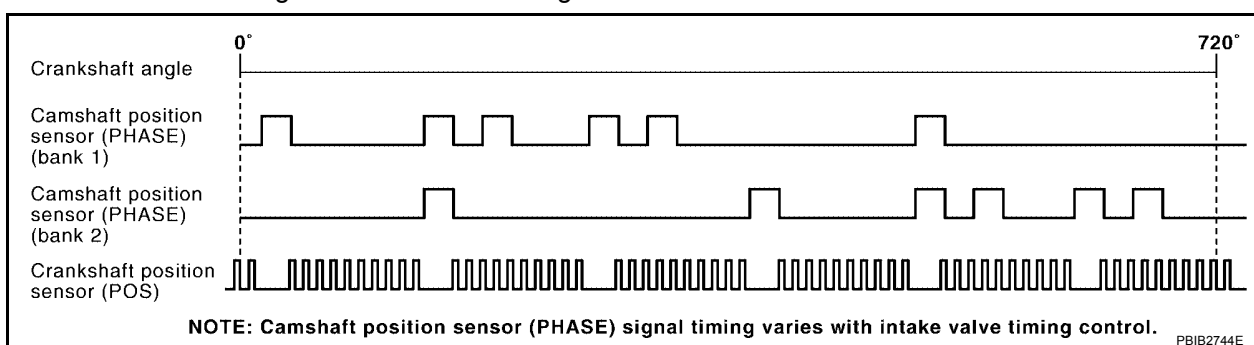
The ECM receives the voltage signal and detects the fluctuation of the engine revolution.

The ECM receives the signals as shown in the figure.
