P0335 CKP SENSOR (POS)

[VQ35DE]

Description

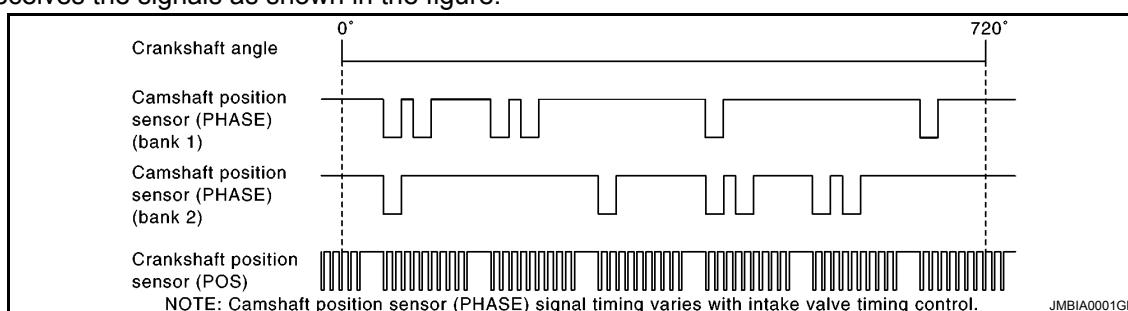
ECM receives the signals as shown in the figure.
