## P0335 CKP SENSOR (POS)

[HR16DE (WITH EURO-OBD)]

#### Description

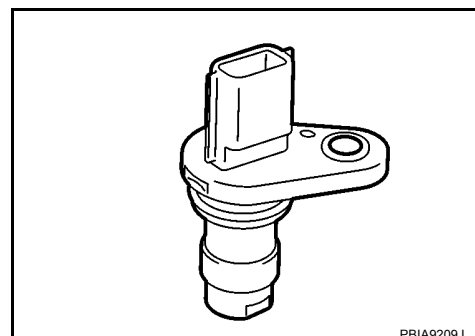
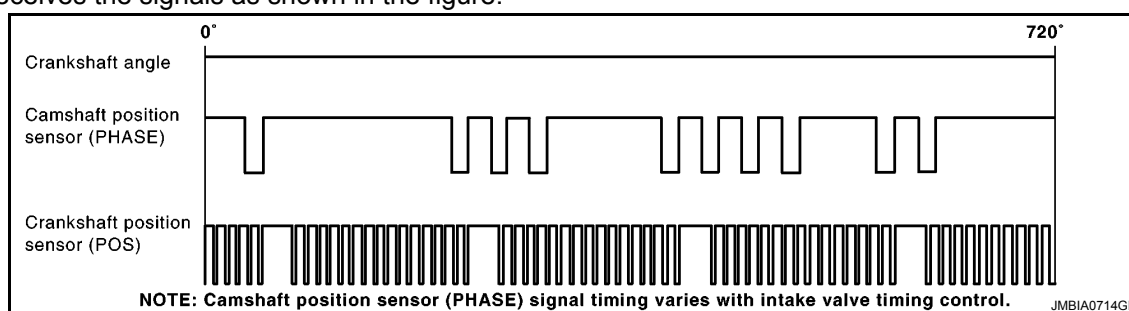
PBIA9209J

The crankshaft position sensor (POS) is located on the oil pan facing the gear teeth (cogs) of the signal plate. It detects the fluctuation of the engine revolution.

The sensor consists of a permanent magnet and Hall IC.

When the engine is running, the high and low parts of the teeth cause the gap with the sensor to change.

ECM receives the signals as shown in the figure.
