# P0335 CKP SENSOR (POS)

[MR20DE]

### Description

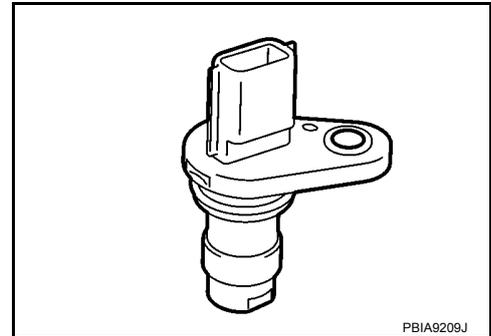
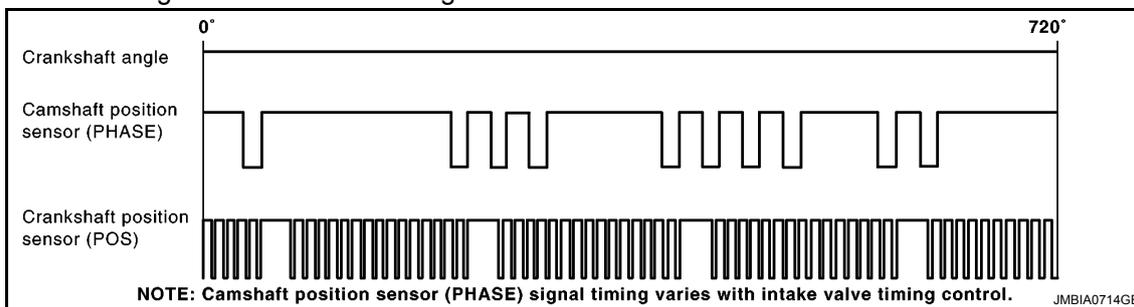
The crankshaft position sensor (POS) is located on the oil pan facing the gear teeth (cogs) of the signal plate. It detects the fluctuation of the engine revolution.

The sensor consists of a permanent magnet and Hall IC.

When the engine is running, the high and low parts of the teeth cause the gap with the sensor to change.

The changing gap causes the magnetic field near the sensor to change.

Due to the changing magnetic field, the voltage from the sensor changes.

The ECM receives the voltage signal and detects the fluctuation of the engine revolution.

ECM receives the signals as shown in the figure.
